THE PHYSICAL EFFECTS OF ATOMIC WEAPONS

PAPER No. 4

The Blast Power of the Hiroshima and Nagasaki Atomic Bombs

W. G. Penney

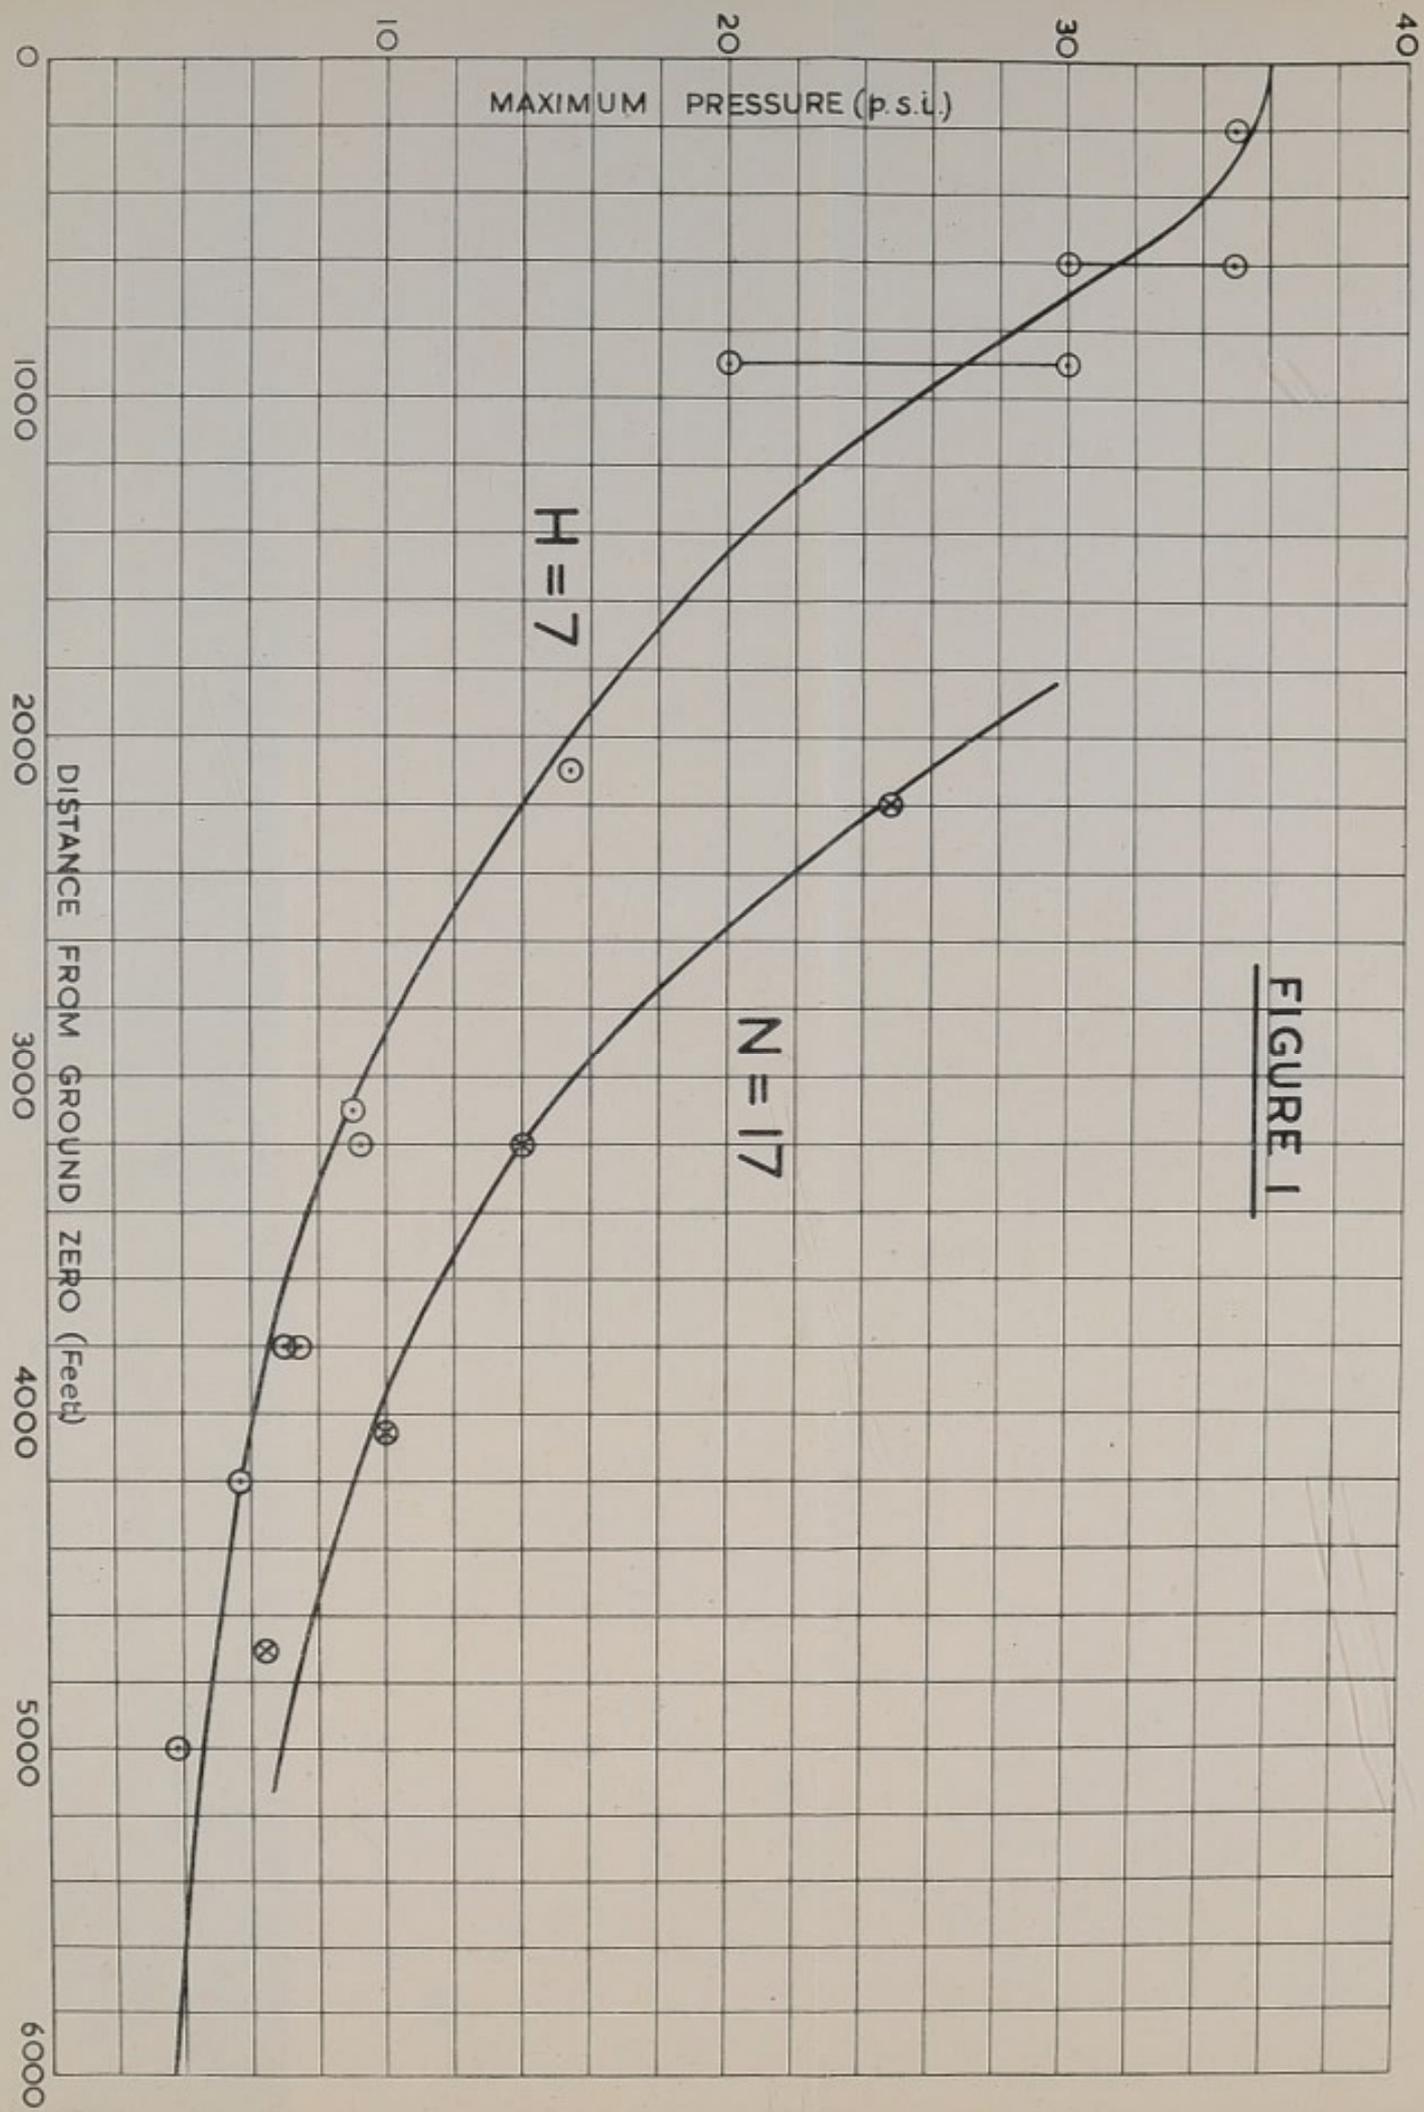
FIGURE 1

Figure 1 shows the observations at Hiroshima plotted as a function of distance. The smooth curve through the results is that for the explosion of a 7200 ton bare T.N.T. charge, 1800 feet above ground level. This curve has been constructed by scaling distances up by a factor of 60 from the experimental measurements of 67 lb. bare T.N.T./R.D.X. charges exploded 30 ft. above ground. The results are given in A.R.D. Explosives Report 16/45.

Figure 1 also shows the observations at Nagasaki, plotted as a function of distance, and the smooth curve drawn through the points is that for 17,000 tons of T.N.T. exploded 1800 ft. above the ground. This curve, also, was obtained from A.R.D. Report 16/45, scaled up by a factor 80 from 67 lb. bare R.D.X./T.N.T. charges exploded 22 ft. above ground level.

As a matter of interest, it is noted that if the Hiroshima bomb was actually equivalent to 7200 tons of T.N.T., the over-pressure on the ground immediately underneath was 36 p.s.i. Similarly, if the Nagasaki bomb were 17,000 tons, the over-pressure on the ground immediately underneath was 100 p.s.i.

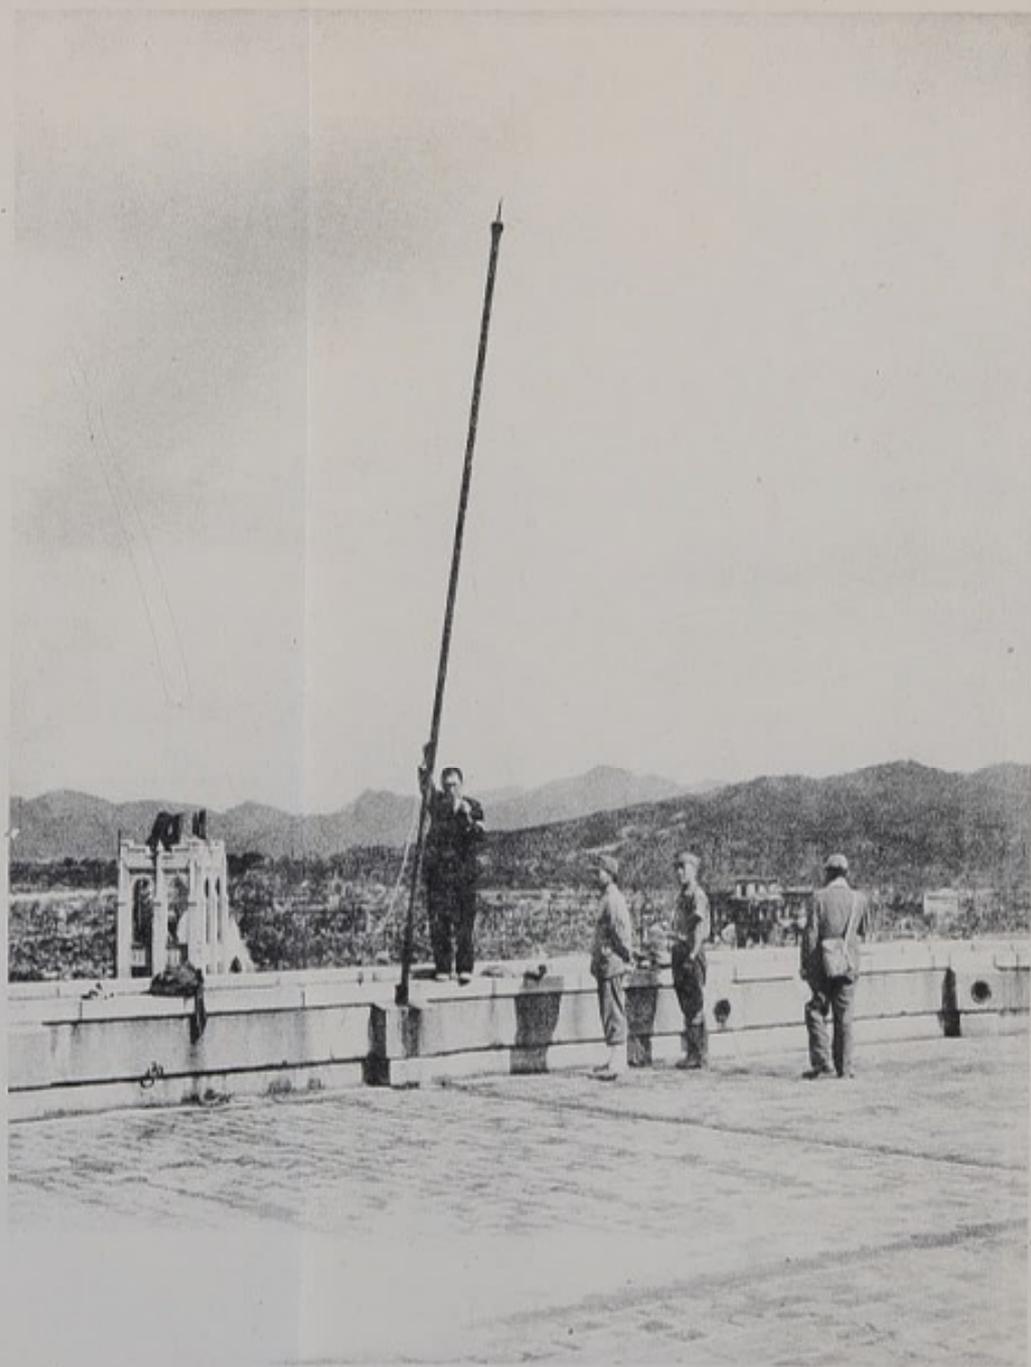
1. A flagpole and lightning conductor bent by the force of the blast wind in Hiroshima. Distance 3200 ft., peak pressure 9.2 p.s.i.

Two observations on the bending of steel tubular flagpoles in Hiroshima, now to be described, are regarded as giving estimates of high accuracy. The first flagpole, from the roof of the bank building 3200 ft. E. of ground zero, was of length 289", outside diameter 2.40", thickness 0.140", had yielded at the bottom through an angle 0.114 radians. The yielding bending moment was measured experimentally to be 9.2×10^4 poundals ft. The drag coefficient finally selected was 0.52, and the peak shock overpressure, after corrections for the yielding had been applied (the correction was 2.2 p.s.i.) was 9.2 p.s.i. Hence

$P = 9.2$ p.s.i. at $R = 3200$ ft. in Hiroshima.

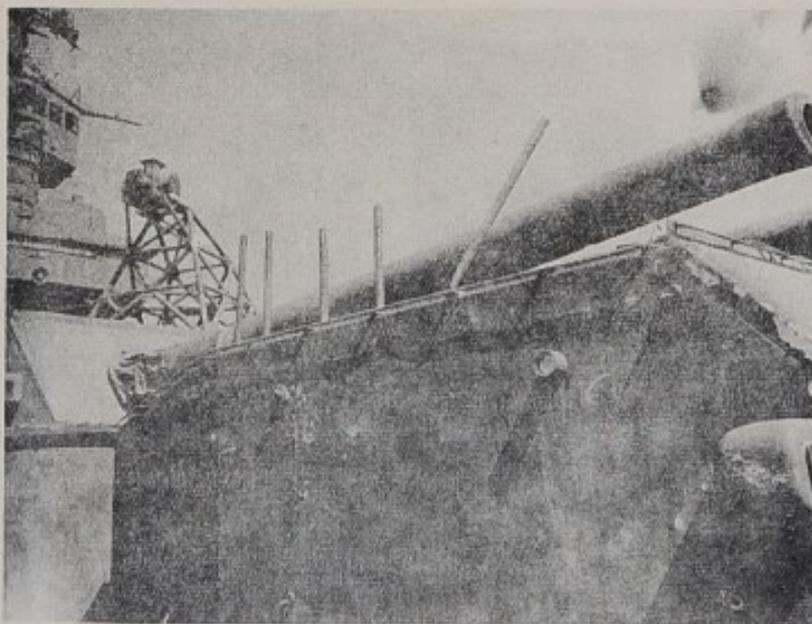
2. A series of blast pipes, of which only the longest has yielded, mounted at Bikini near a foil meter tower.

To substantiate the claim that the accuracy was of the order 10 per cent., pipes of the same type were put on a number of ships at Bikini, and near to them other more conventional instruments were placed. Photograph 2 shows one example. The analysis summarised above was applied and the results in this case compared with the peak pressure obtained from the rupturing of a number of aluminium foils contained in the "foil meter tower". The results were completely satisfactory.

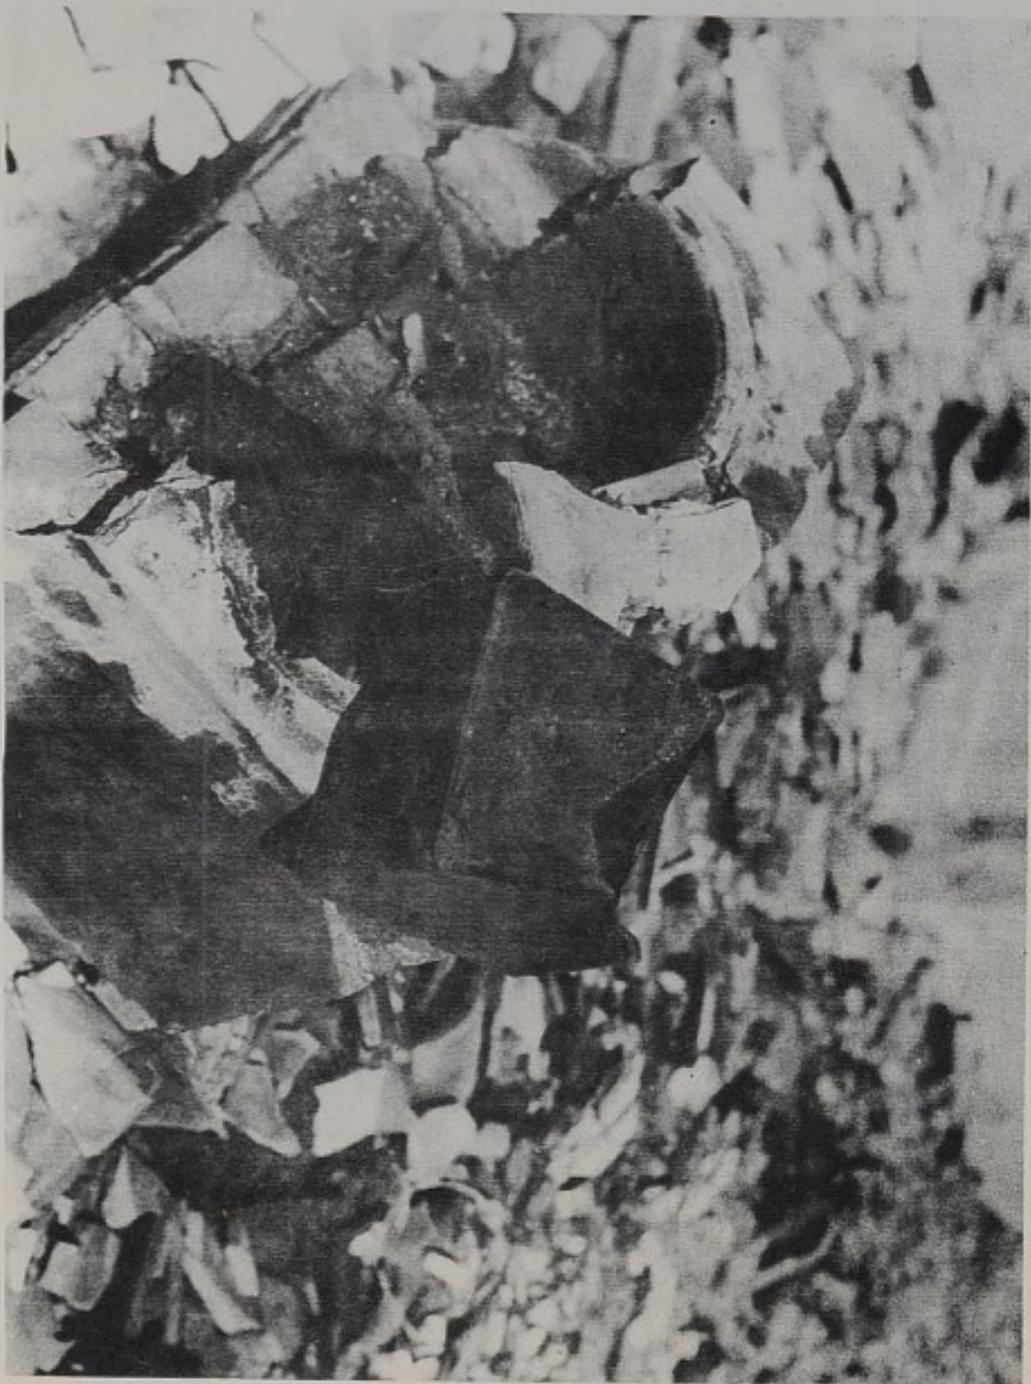
4. A crushed oil can in Hiroshima. Distance 4100 ft., peak pressure 6 p.s.i.

A crushed can was found 4100 ft. S. of ground zero in the yard of a small machine shop in Hiroshima. The compression ratio was 1.22, and the adiabatic pressure was 4.65 p.s.i. The strength of the can in the crushed state was about 1.3 p.s.i. Hence

$$P = 6 \text{ p.s.i. at } R = 4100 \text{ ft. in Hiroshima.}$$

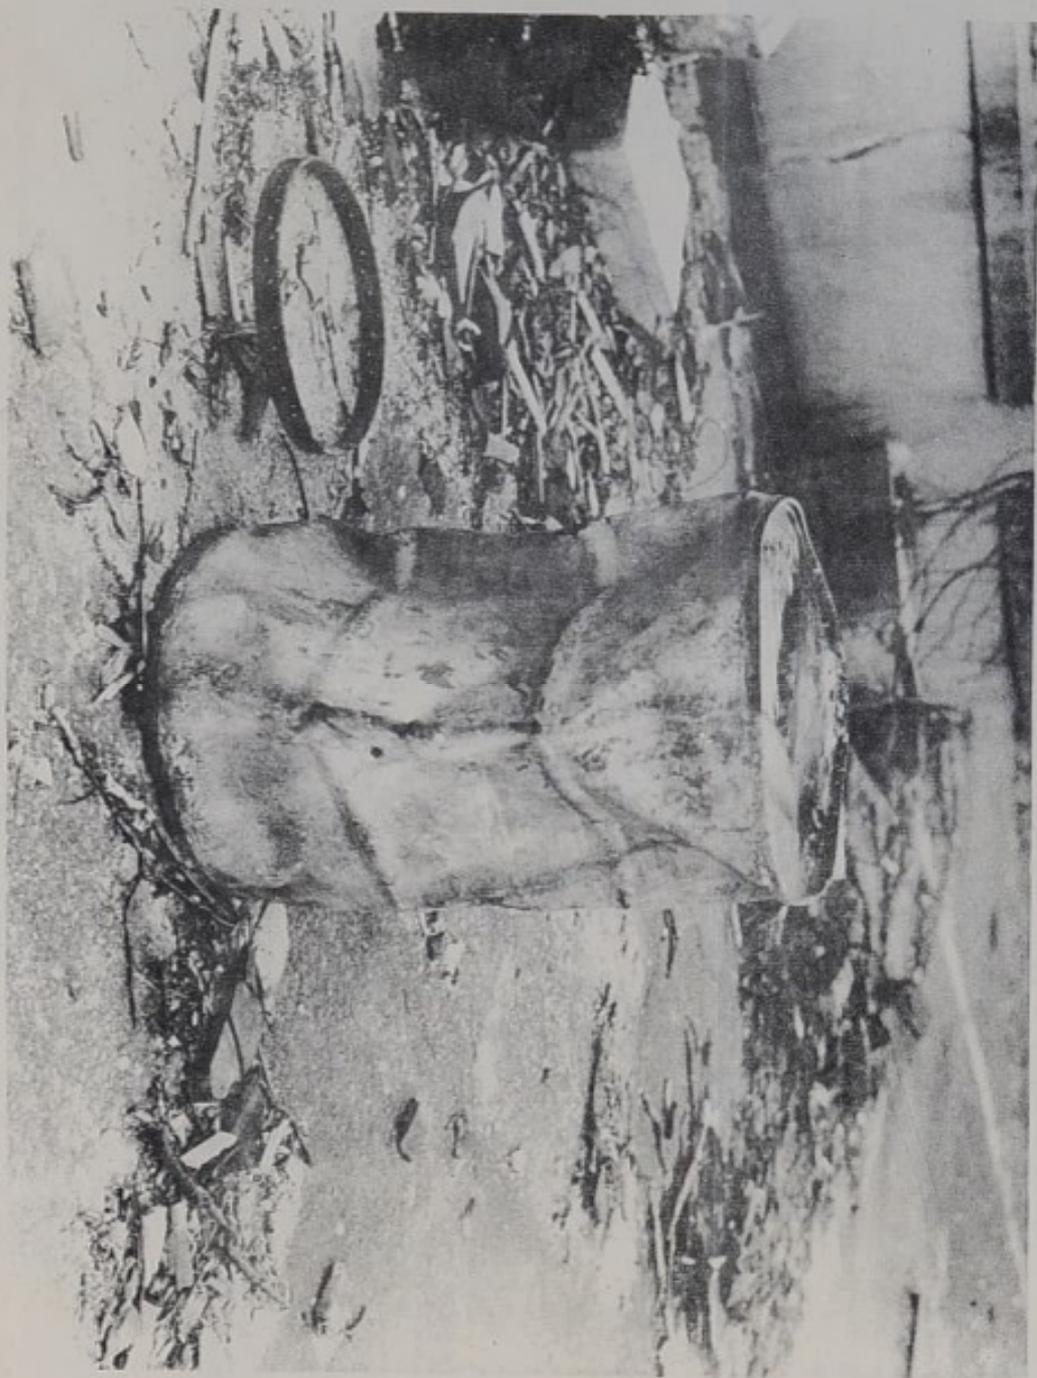
5. A crushed 40 gallon oil drum in Hiroshima. Distance 900 ft., peak pressure 20 - 30 p.s.i.

A crushed 40-gallon petrol can was found in the open, 900 ft. from the ground zero in the yard of the Prefectural Display Hall on the away side of the blast in Hiroshima. From tests made on this particular type of can, collapse occurs at 18-20 p.s.i. Experiment has shown however, that equation (1) is not reliable at such high pressures, although collapse does not occur below 18 p.s.i. The collapsed cans can withstand 15-25 p.s.i. The compression ratio was about 1.5, so that the maximum pressure was of the order 20 p.s.i., and might have been 25 p.s.i. Some deduction might be necessary to allow for wind pressure. We have with reasonable certainty that the maximum pressure was 20-25 p.s.i. at $R = 900$ ft.

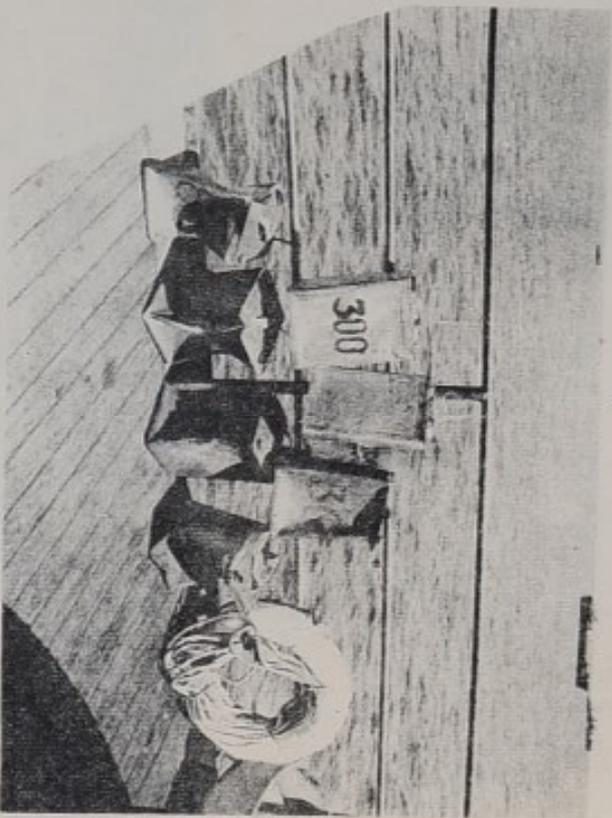
6. Crushed 5 gallon drums at Bikini covering pressure range 3 - 30 p.s.i.

The blast wave from the air-burst Bikini bomb was measured by means of the compression of 5-gallon and 55-gallon (U.S. gallons) petrol cans and drums. The results were surprisingly successful and reproduced within 2 per cent. the pressure-distance curves obtained from more 'scientific' devices. Indeed, the results from the cans showed less scatter than the other instruments since the latter usually required to be set up either exactly facing the blast, or in the side-on position. As the bomb was to be dropped from an aircraft, it was impossible to set out the instruments with the alignment that they needed to give accurate readings, and the results actually obtained, due partly to the large bombing error and to the movement of the ships on their moorings, showed considerable scatter. However, so many readings were taken that firm conclusions about the blast were obtained.

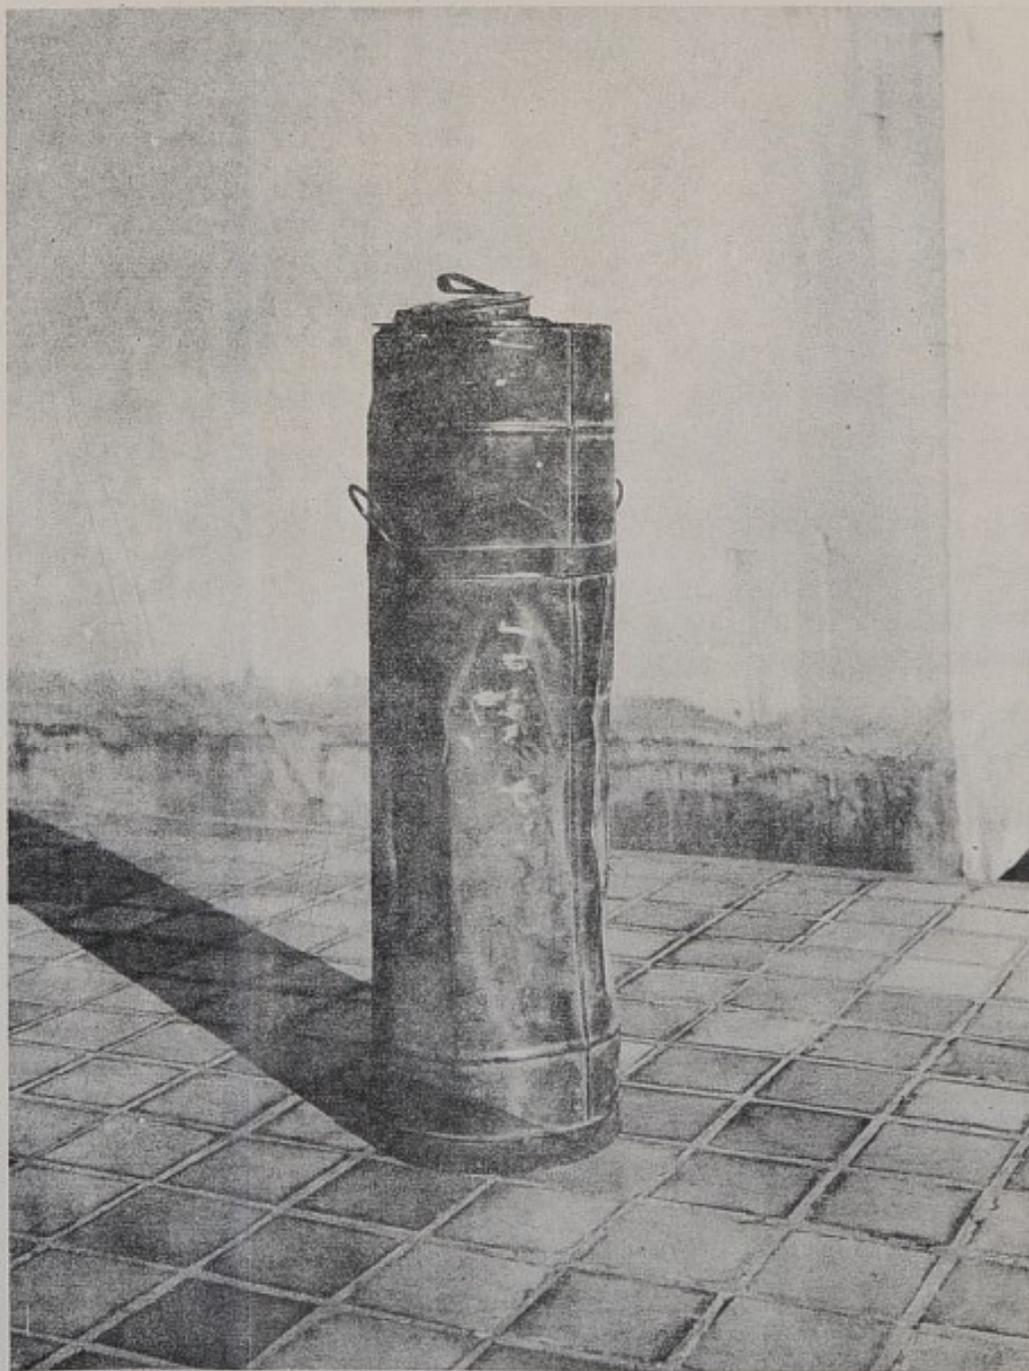
7. Crushed blue - print container from Hiroshima. Distance 5000ft., peak pressure 3.8 p.s.i.

Four blue-print containers of excellent construction, one of which is shown in photograph 7, were found in the Communications Bureau, 5000 ft. ENE of the point under the explosion ground zero at Hiroshima. The lids, which had rubber washers, were tightened into position with a lever on a handle. The containers, even in their crushed condition, were almost air tight; as the pressure outside fell, the lid opened, leaving the can in an exact register of the maximum pressure. All four were equally crushed and one was brought back for test.

Original volume	57125 c.c.
Volume in collapsed state	51525 c.c.
Loss in volume	9.8 per cent.
Pressure developed	2.28 p.s.i.
Strength in the collapsed state	0.81 p.s.i.
Maximum pressure	3.1 p.s.i.

The peak hydrostatic pressure at 5000 feet is therefore deduced as $3.1 (12)^{1/12}$ or 3.2 p.s.i.

$$P = 3.8 \text{ p.s.i. at } R = 5000 \text{ ft. in Hiroshima.}$$

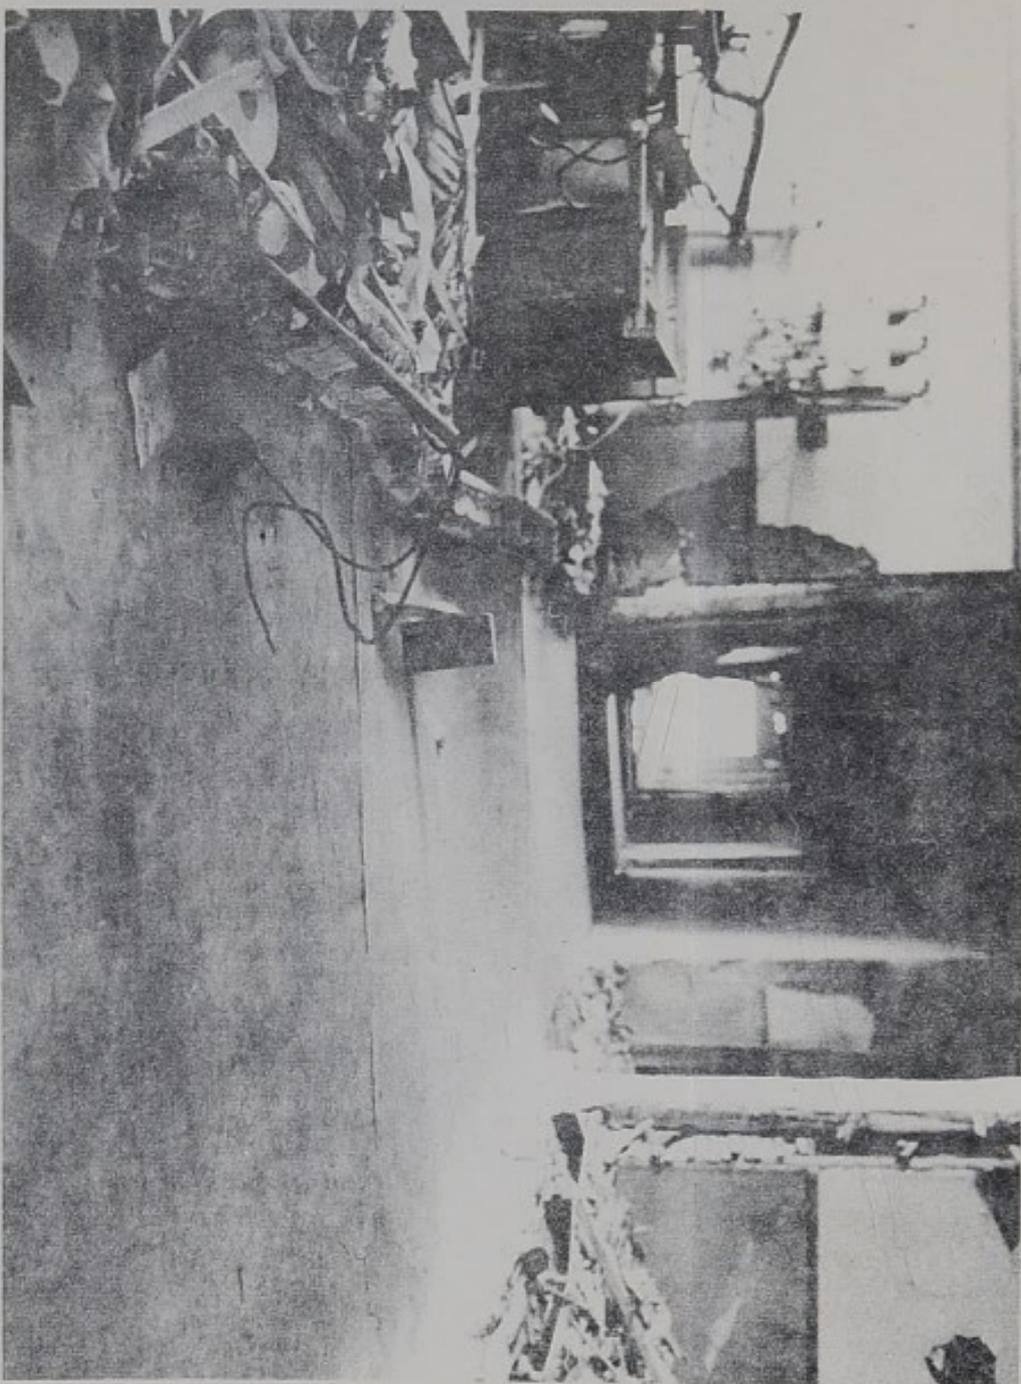
8. Dished concrete panels of the ground floor of the Administration Building in the Torpedo Factory at Nagasaki. The basement was practically air tight and was used as an air - raid shelter. Distance 4050 ft., peak pressure 10p.s.i.

The ground floor of the Administration building of the Torpedo Works in Nagasaki, 4050 ft. N of ground zero, acted as the roof of an air raid shelter. The shelter was practically unventilated; the windows, which were in any case small, had been almost entirely bricked-up. The only opening was the door at the top of the stairs connecting the ground floor to the basement. The basement was about 100' x 30' x 9'. Thus, when the explosion wave reached the building, the pressure in the shelter did not change. On the other hand, the large window space at ground floor level allowed the pressure inside to rise very rapidly. The effect of the pressure difference on the two sides of the reinforced concrete floor was to dish in most of the panels. A careful study was made of the construction of the floor by knocking a 4' x 4' hole in it, and details of the reinforcements were obtained. There were three similar panels and the dishing was 9.5", 9.8" and 4".

The problem as to what the pressure was to cause these observed dishings was put in 1945 to the Concrete Section of the Road Research Laboratory. The concrete was considered to be of reasonable quality, the Radio Building sample perhaps being slightly the better, as might be expected, since the Radio Building was built before the war, while the other was built during the war. The exact amount of dish was not considered significant since the panels would give their maximum resistance before they first failed.

The panels at Nagasaki were 15' x 23', while those at Hiroshima were 14'3" x 20'. There was 25% more steel in the Nagasaki panel per square foot than in Hiroshima, but the depth between centres was the same.

Absolute estimates of the collapsing pressures could not be given by the Road Research Laboratory, but it was thought that the figure must be between 10 and 20 p.s.i., probably much nearer to the former figure. By drawing a smooth curve through the other results obtained at Hiroshima, the pressure was 9 p.s.i., and it was considered that 10 p.s.i. was therefore an accurate value for Nagasaki. This value of 10 p.s.i. at 4050 ft. in fact agrees very closely with the 17,000 ton value (9.5 p.s.i.) and thus produces results entirely concordant with our expectations.

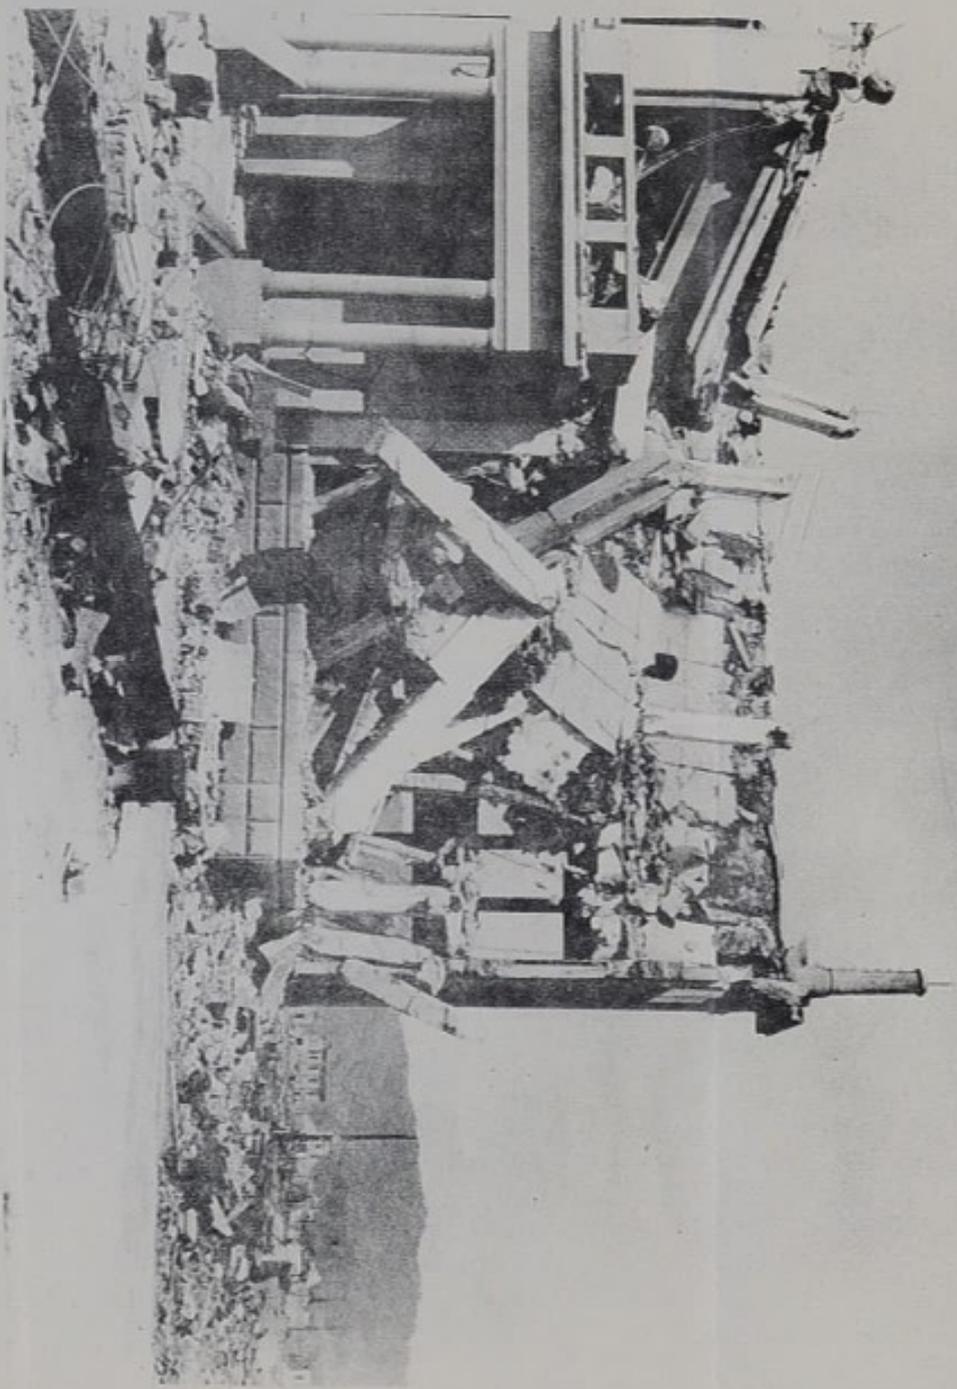
9. A reinforced concrete building almost vertically under the Hiroshima bomb. The building did not have a steel frame. Peak pressure 30 p.s.i.
